**MAGISTRATES COURT OF SOUTH AUSTRALIA
(INDUSTRIAL OFFENCES JURISDICTION)**

MARKOS, Ian

QUIN INVESTMENTS PTY LTD
First Defendant

KUZUB, Nikolai
Second Defendant

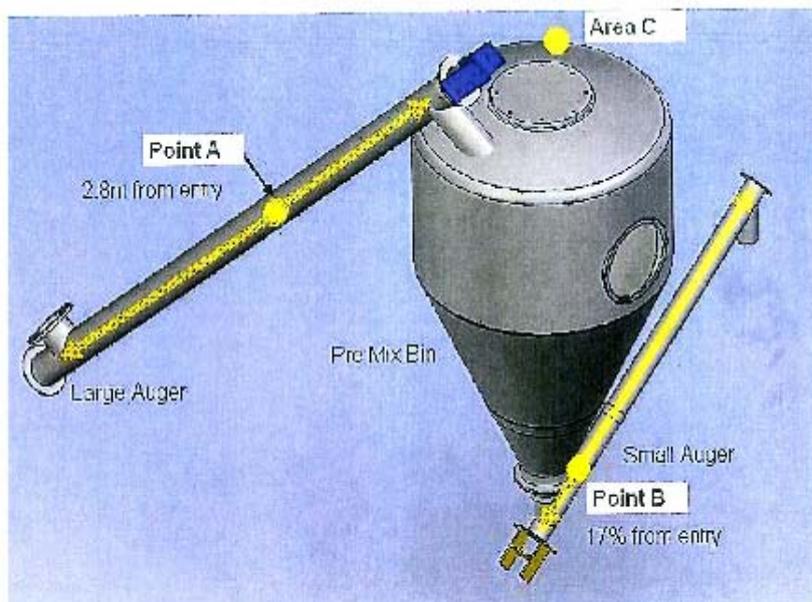
Figure 9 The three vessels in which detonation occurred.
